Manhole Inspection Summary

Manhole # S49A__006MH

Insp Date: **10/2/08 9:33 AM**

Location Address: **2618 orleans st**

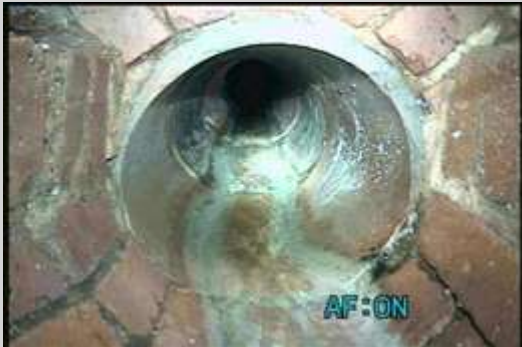
12 O'Clock Outflow

8 in. Circular Gravity Sewer
Pipe Out @ 12 O'Clock

Pipe Material: **Clay** ☐ Pipe Lined

Invert Depth: **7.58** (ft.) Flow Characteristics: **Fast**

Deposits: ☒ None ☐ Mud ☐ Sludge ☐ Debris ☐ Grease

Infiltration: **None** Pipe Seal Cond: **Unknown**

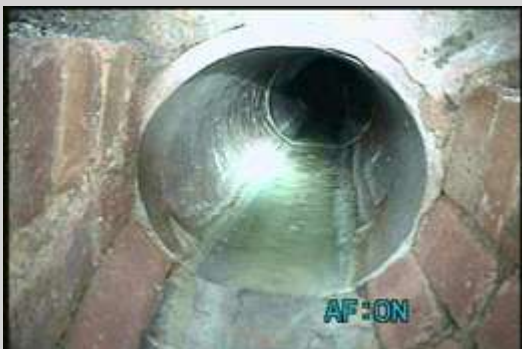
9 O'Clock Inflow

8 in. Circular Gravity Sewer
Pipe In @ 9 O'Clock

Pipe Material: **Clay** ☐ Pipe Lined

Infiltration: **None** Pipe Seal Cond: **Unknown**
